Greenland Enterprises

Post-Accident Inspection

VAMC Gainesville, FL

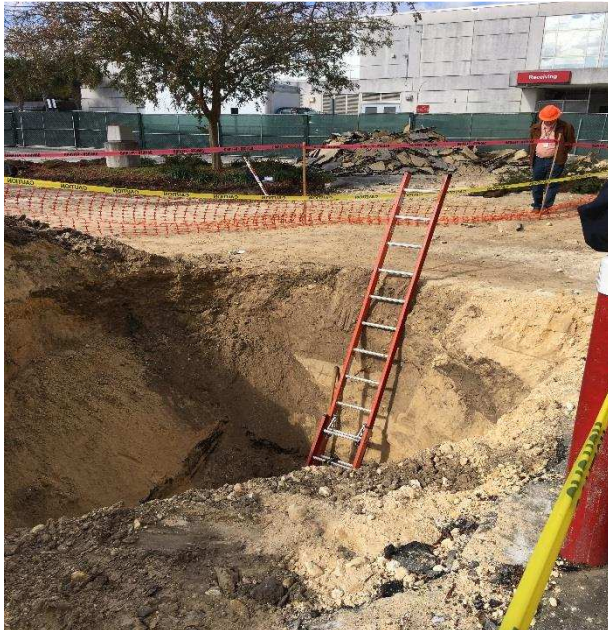
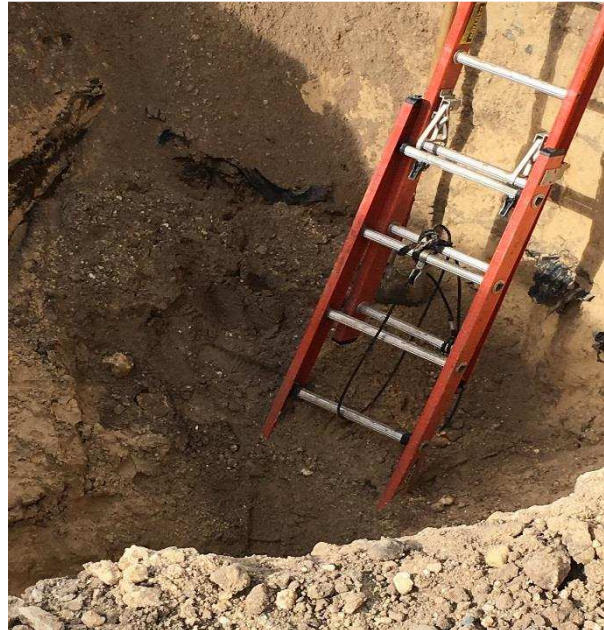
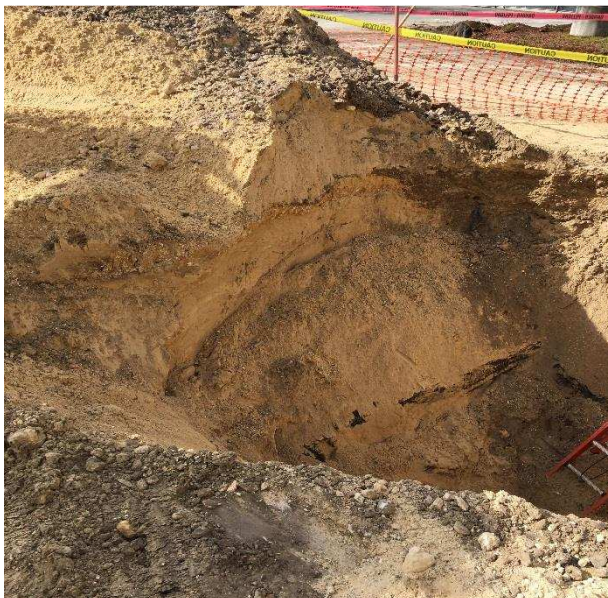
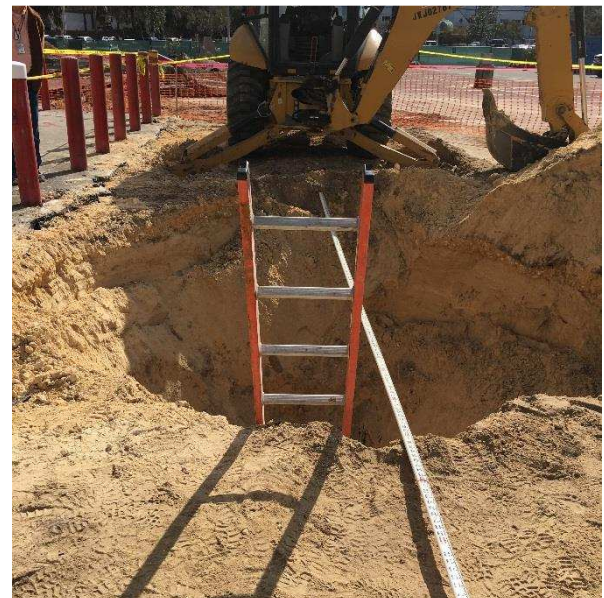
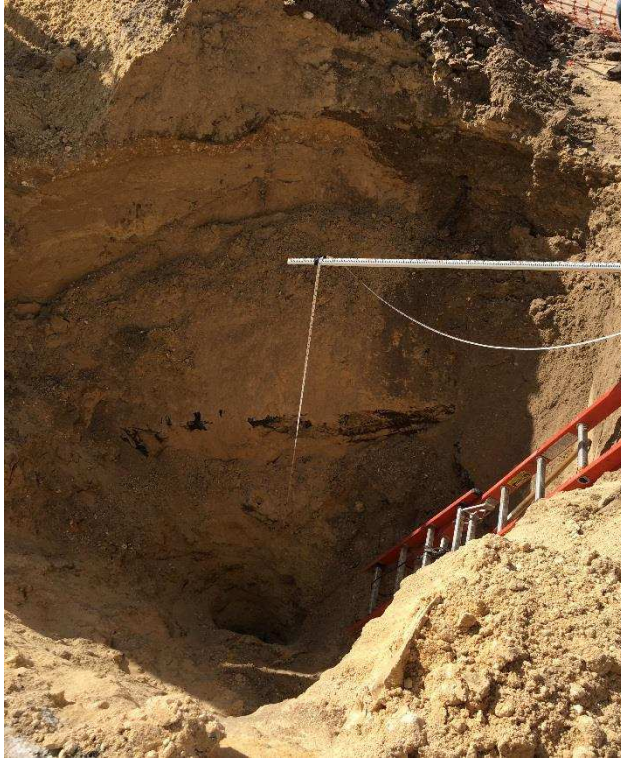
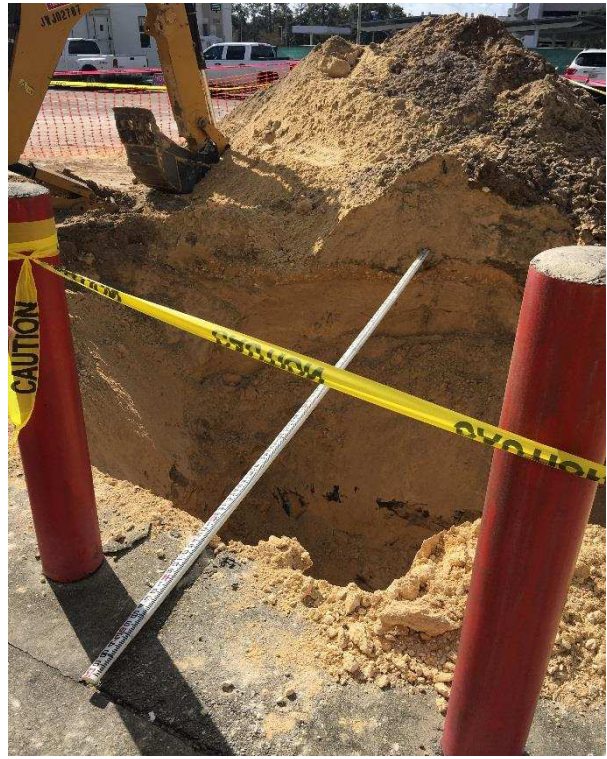
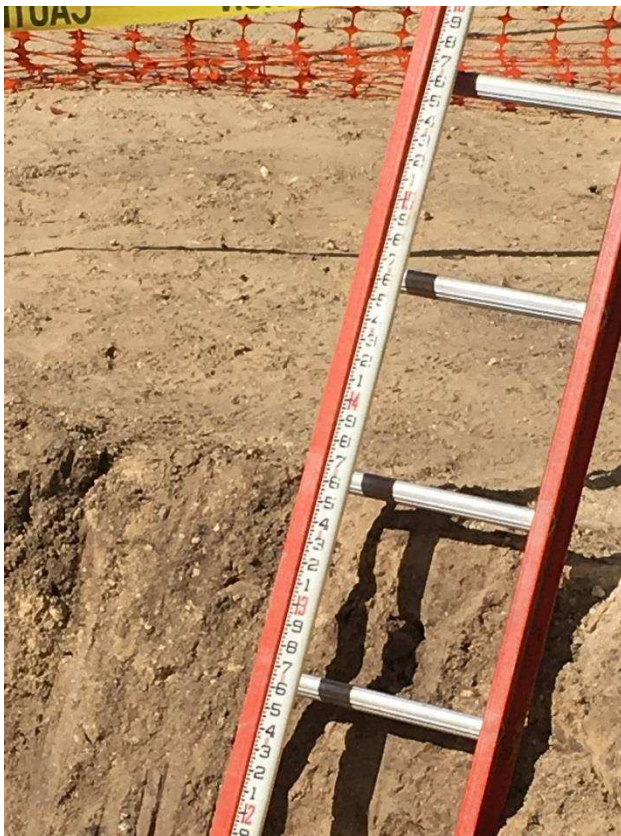
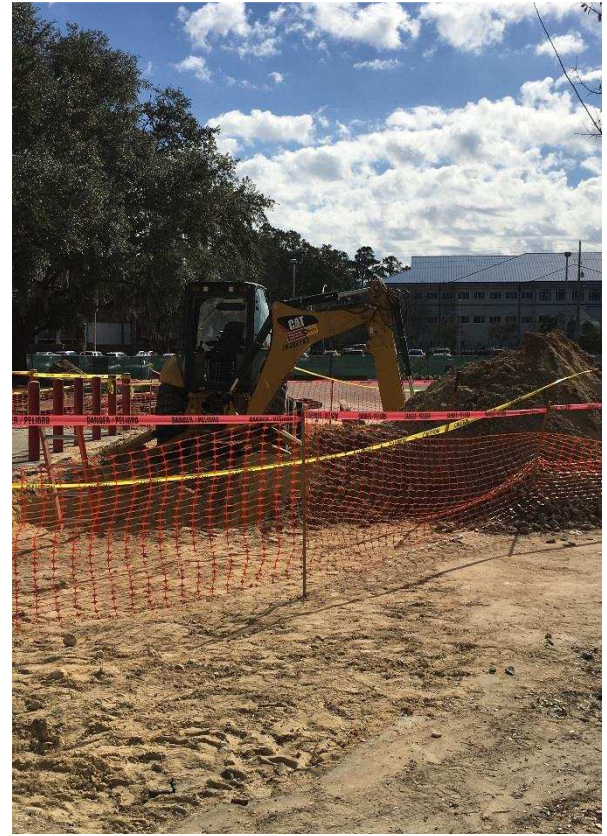
North East Corner of Building 25

Excavation

- TES provided no protective system for employees working in an excavation deeper than 5 feet.
- Spoil pile not set back 2' from the edge of the excavation

- If an entry was made, a protective system was required (sloping, shielding, or shoring).
- Spoil pile was not located 2' away from the edge of the excavation. This additional weight of the spoil pile probably contributed to the collapse along with the type of soil present.

- Review accident and findings with SAW, Greenland, and OELRICH Construction personnel to create awareness and possible reoccurrence.
- Treat all excavations and trenches as if they are Class C type soil, which requires the use of protective systems. Recommend making this a company policy for all project sites.
- Review and document the APP plan with all subcontractors on site
- Conduct monthly safety audits and/or have an SSHO on site
- The general contractor should conduct frequent and regular inspections of the site and document these inspections.

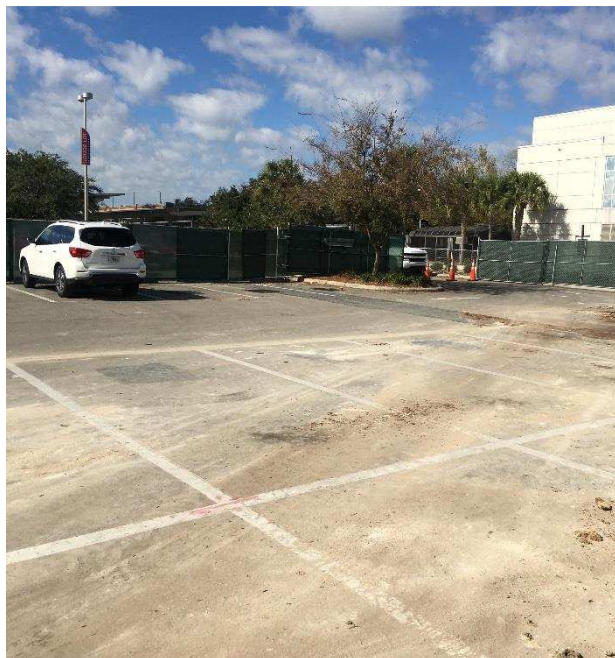
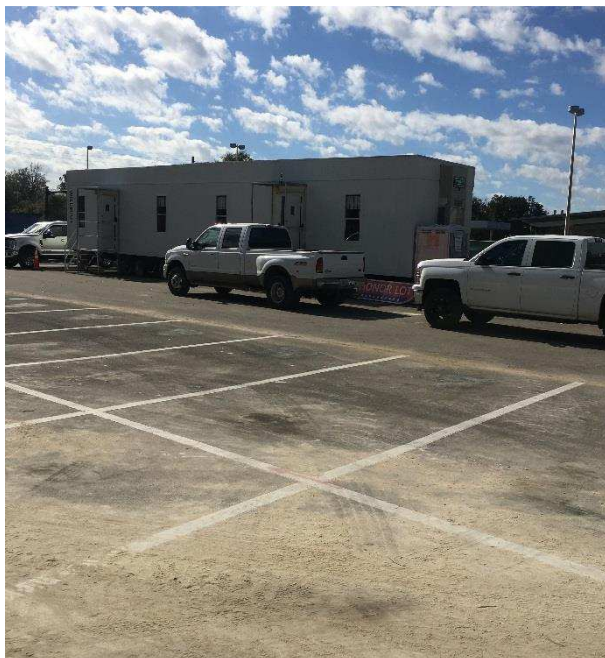
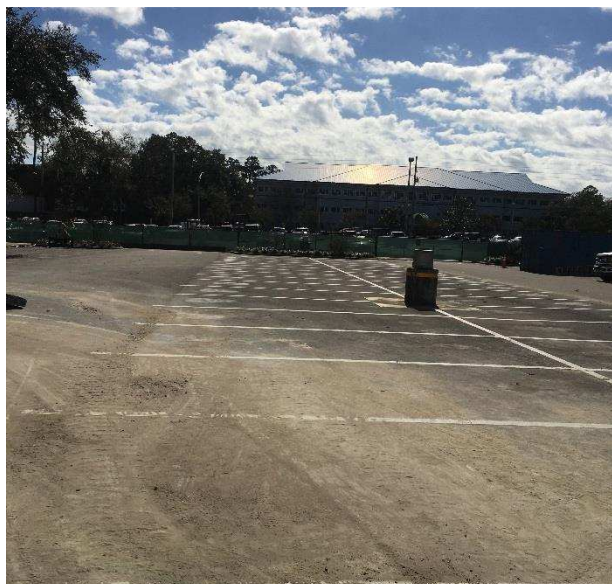
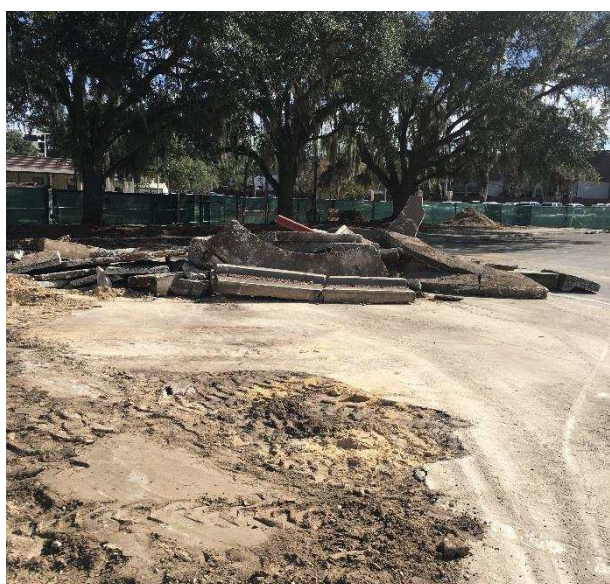
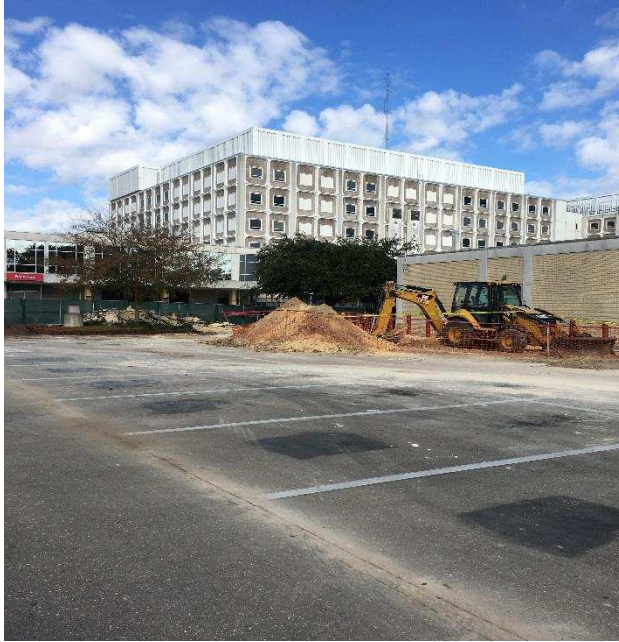
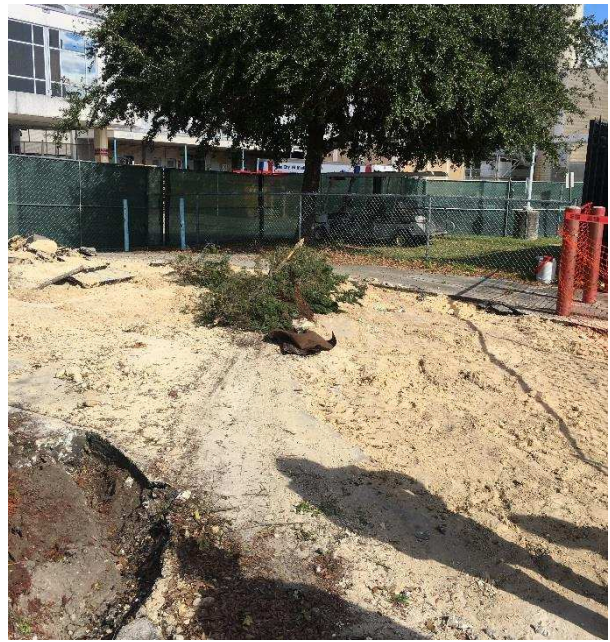
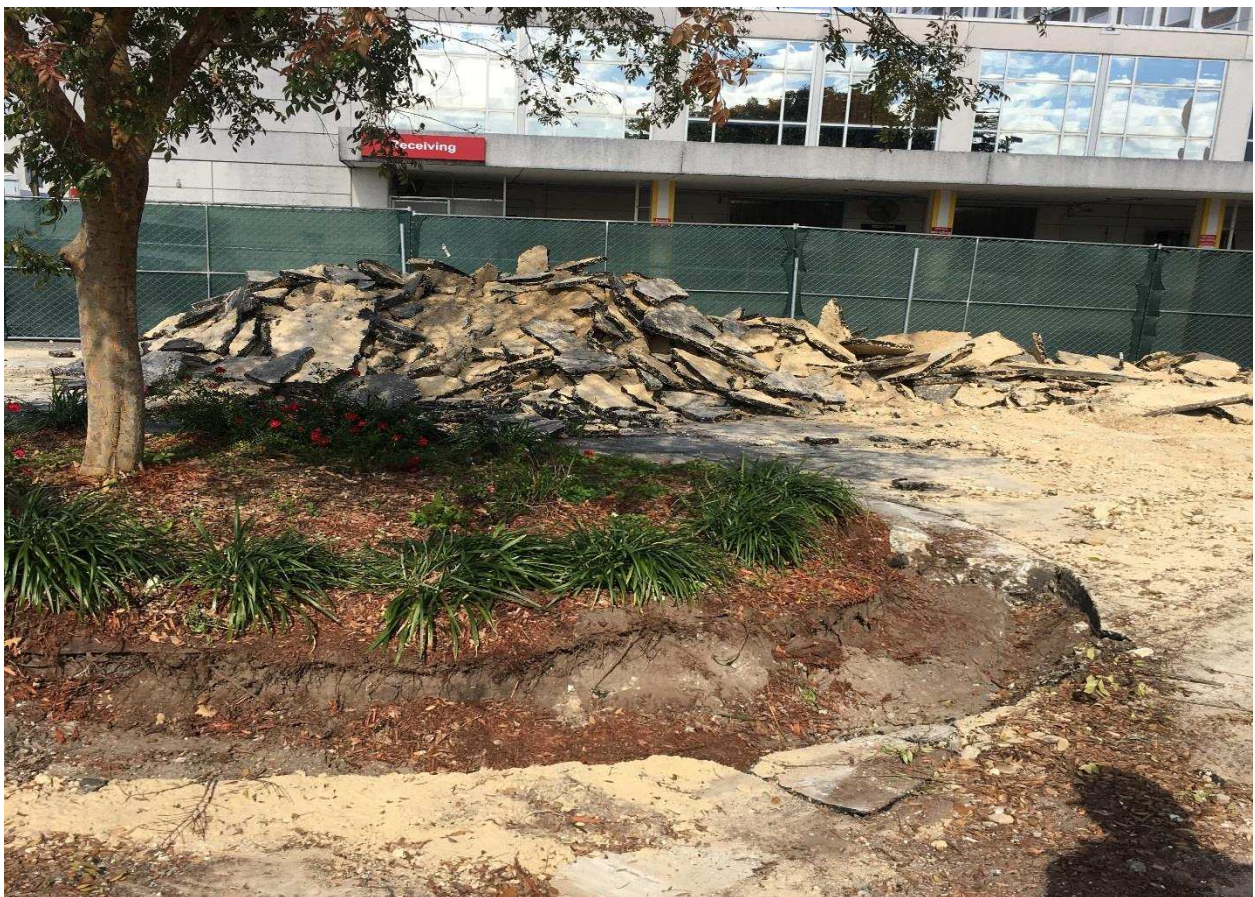
Project Site

Areas around project site
